# Manhole Inspection Summary

Manhole # S17EE2009MH

Insp Date: **8/7/08 12:17 PM**

**Location** Address: **5811 LOCHLEA RD**

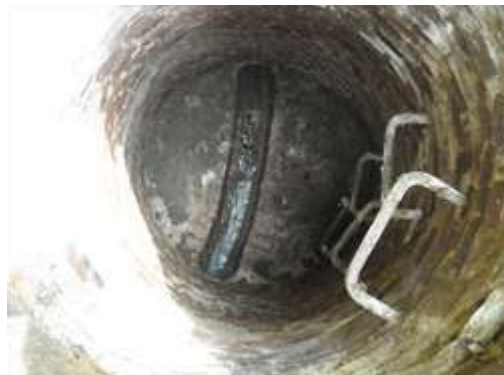
Top View

Corbel and Barrel infiltration. Evidence of surcharge - Bench debris.

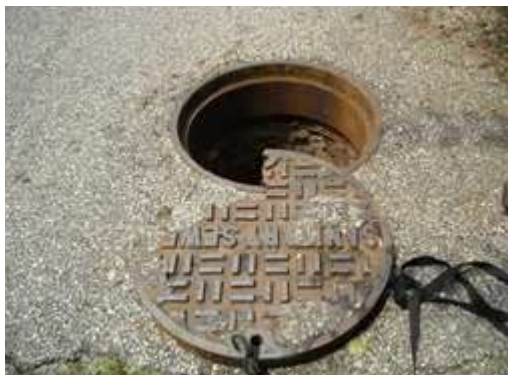
Broken lid

Comments **BROKE AND REPLACED LID; RETRIEVED BROKEN PIECES FROM BOTTOM OF THE MANHOLE.**

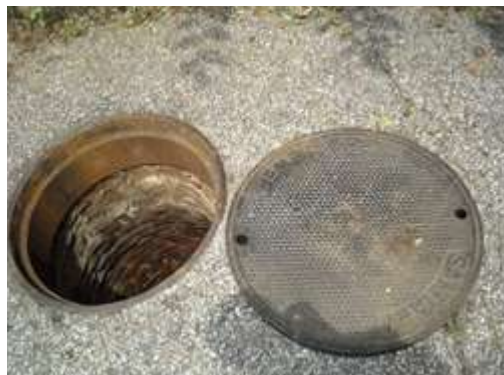
Replaced lid

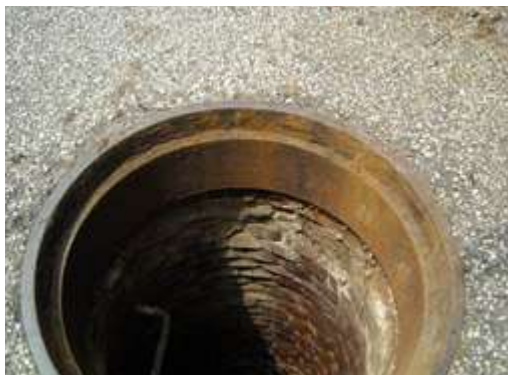
Defect

Frame leaks. Adjustment deterioration and infiltration.

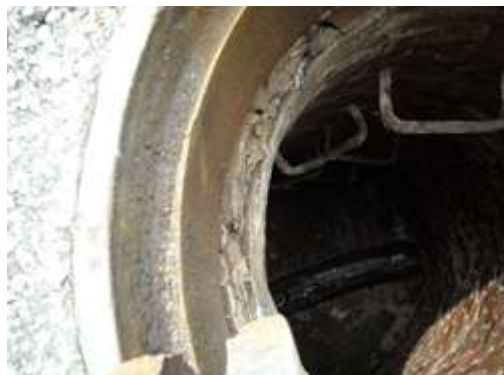
Defect

Frame leaks. Adjustment deterioration and infiltration.

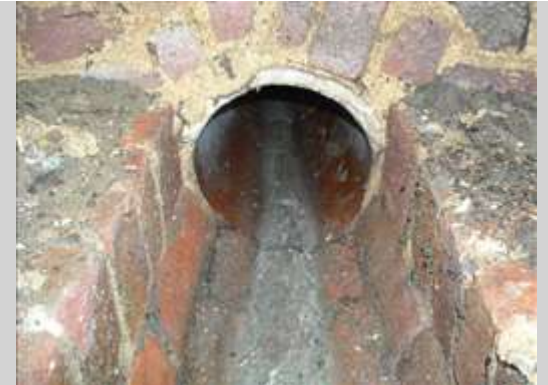
### 8 in. Circular Gravity Sewer Pipe Out @ 12 O'Clock

Invert Depth: **9.70** (ft.) Flow Characteristics: **Slow**

Infiltration: **None** Pipe Seal Cond: **Unknown**

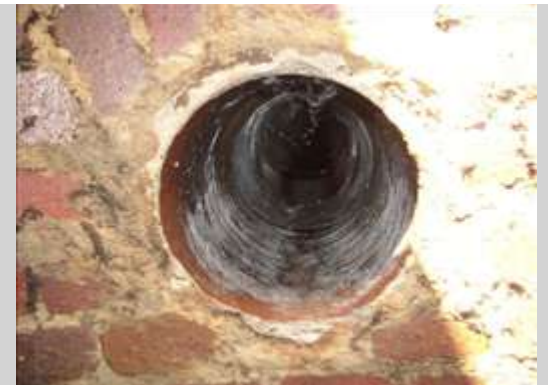
### 8 in. Circular Gravity Sewer Pipe In @ 7 O'Clock

Infiltration: **None** Pipe Seal Cond: **Cracked**

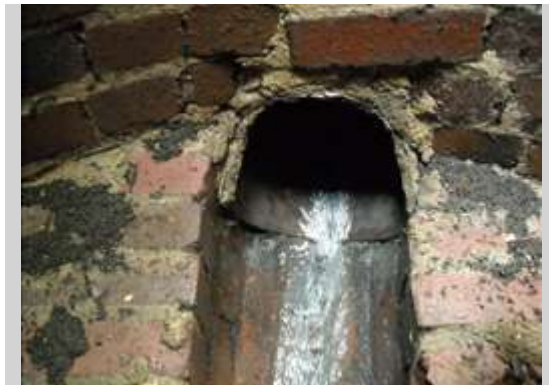
### Drop In @ 7 O'Clock

Drop: **Outside** Rod and Bar

Drop Condition: **Open**
